# Hydro-Engineering Solutions, LLC

December 14, 2012

RE: Beck's Farm 5 Floodplain

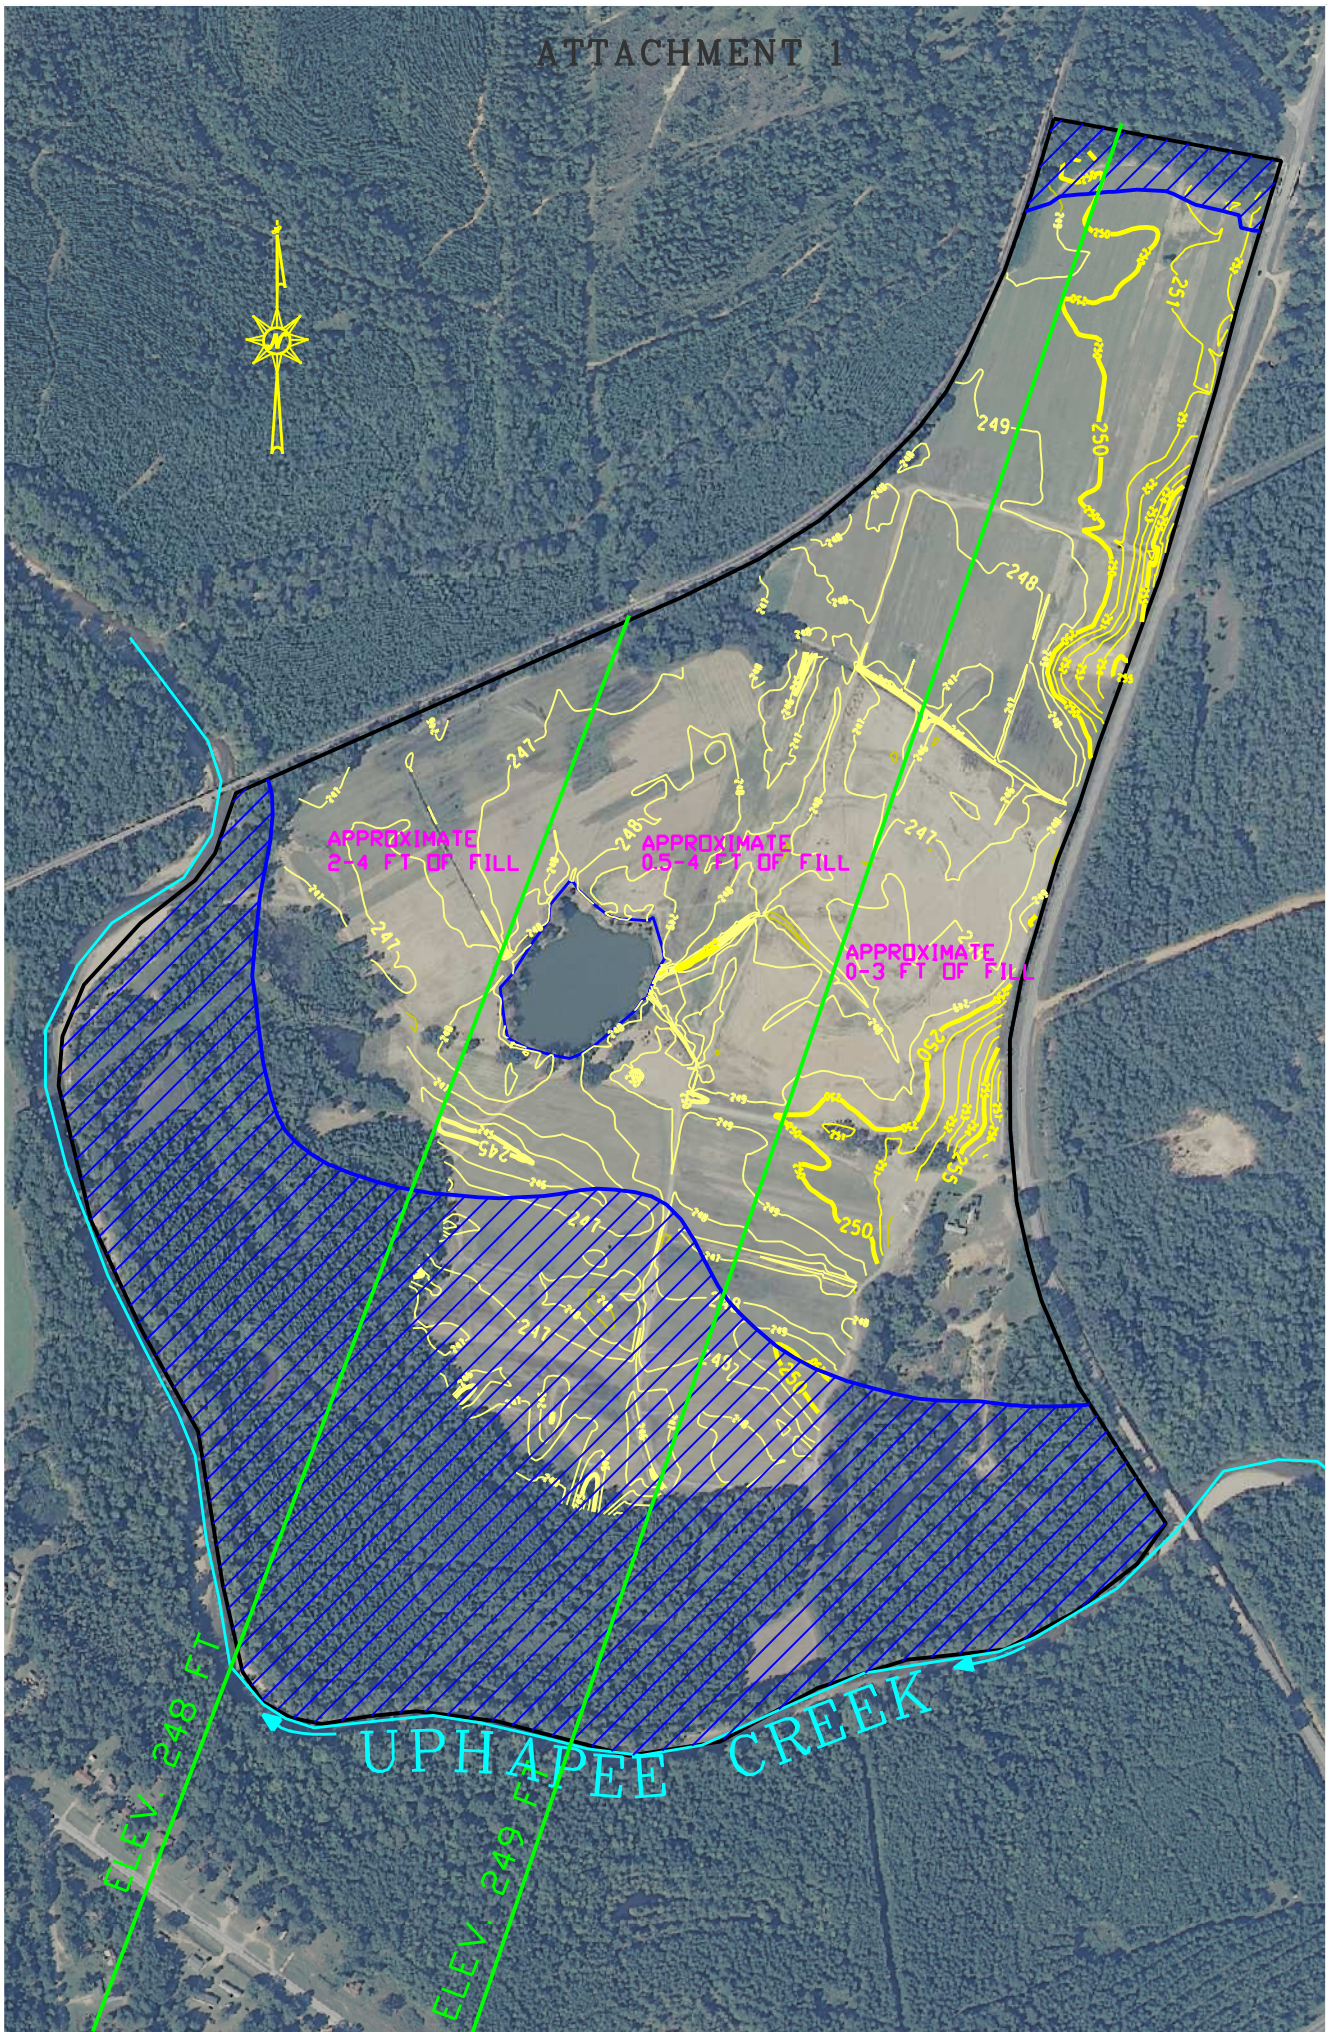
ATTACHMENT 1

Beck's Turf Farm 5, located in Macon County, Alabama, on the north side of Uphapee Creek, approximately 0.5 miles north of Interstate 85 at Exit 38, in the northeast  $\frac{1}{4}$  of the northwest  $\frac{1}{4}$  of the Tuskegee quadrangle, in sections 1 and 12 of Township 17 North, Range 23 East, exists within the limits of a Federal Emergency Management (FEMA) detailed study. The site is bounded by State Route 81, the CSX Transportation Railway, Uphapee Creek and Red Creek. State Route 81 provides access to the site. The detailed study extends upstream and downstream of the site following Uphapee Creek (see Attachment 1).

The site is approximately 277.1 acres. Approximately 133 acres of the site is developable land outside of the published FEMA 100-year floodplain boundary. Land within the floodplain may be developed following FEMA's process for a Letter of Map Revision. However, the land outside of the published floodplain will not require a Letter of Map Revision. This land is very flat with some ditches and swales. Due to years of sod farming on the site, some areas outside of the published floodplain boundary are lower than the 100-year elevation. Fill may be required in these areas to raise low spots to a foot above the 100-year floodplain. This may require 0.5 feet to 4 feet of build up in some areas. Building and Earth Sciences, Inc performed a preliminary subsurface exploration and geotechnical engineering evaluation of the site. Their report states that the majority of soils encountered at the site should be suitable for structural fill. Therefore, any fill needed may come from onsite, although there are several areas near this site that would be suitable borrow for fill material as well. If you should have any questions or need anything else please do not hesitate to call.
